Reconstruction Support after the Great East Japan Earthquake

Kan Kumagai

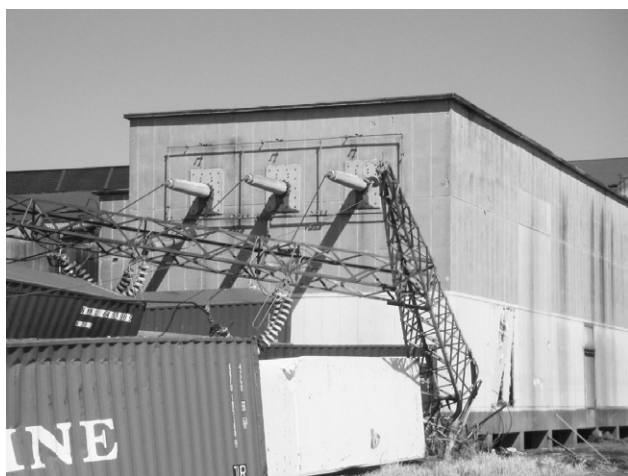
Fig. 1 Destroyed Power Receiving Substation

At the extra high voltage substation (power receiving station), an overhead transmission line from the power company was connected through bushings; however, all metal conductors had been cut by the collapse of the steel tower. Fig. 1 shows an overall view of the destroyed power receiving substation.

It was subsequently revealed that insulation oil had leaked out of the wall penetration type bushings by the effect of insulator fracture and breakage of parts. We concluded that reuse would be impossible in the state it was in without taking any corrective measures.

The steel tower falls down and incoming bushings are exposed.

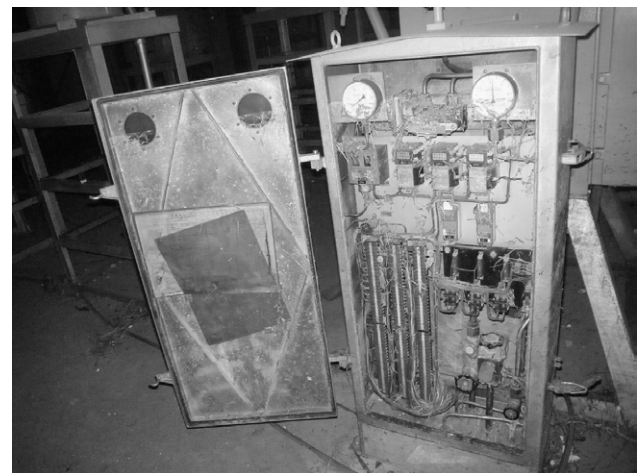
Fig. 2 Operational Block of GCB

Of the damage assessed, there were our supplied two 168kV Gas Circuit-Breakers (GCBs), one Vacuum Circuit-Breaker (VCB) and one GCB made by another supplier. At the power receiving station, there was seawater that had flooded up to 1300mm above the floor level. Except for our supplied VCB, control circuits for all the GCBs could not be reused. Fig. 2 shows the operational block of GCB in the damaged state.

control circuits of our GCBs with water. After drying out, we performed an operation check test. The equipment seemed to function, but opening and closing time had discrepancies. Since retardant operation of internal protection relays was discovered, we concluded that we should discontinue the use of these circuit-breakers.

Seawater entered the interior of the operator box and driftage is attached.

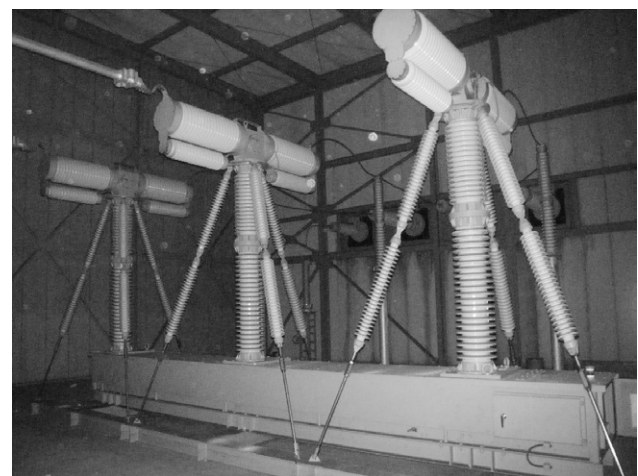
Fig. 3 168kV VCB

The disconnecting switch remained without any particular damage; therefore, we decided to continue to use it. Fig. 3 shows the 168kV VCB.

The operating mechanism seems to be free from particular damage.

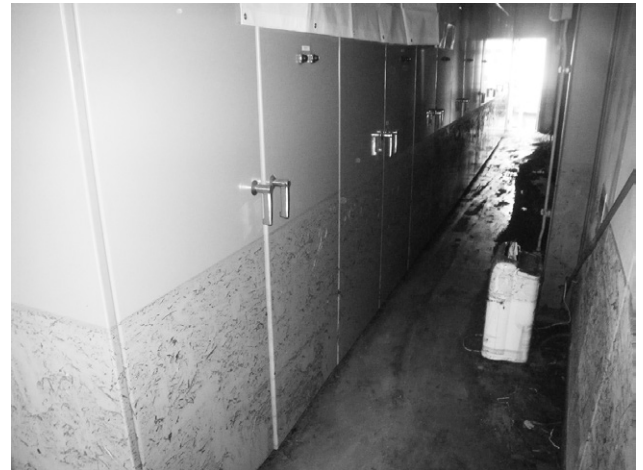
Fig. 4 22kV Switchgear

Fig. 4 shows the 22kV switchgear hit by the flood. Since the 22kV switchgear was installed inside the power receiving station, 50% of the switchgear was submerged in the seawater and this made it impossible to continue to use this product. To accomplish the program of Step I, we decided to use some of the units therein for temporary power transmission at 22kV. Since it was difficult to restore the control circuit for the VCBs within the restoration schedule of Step I, these VCBs were temporarily restored as a disconnecting switch to be used until the delivery of new products. **Fig. 5** shows the interior of 22kV switchgear damaged.

Seeing from contamination, intrusion of seawater was clear.

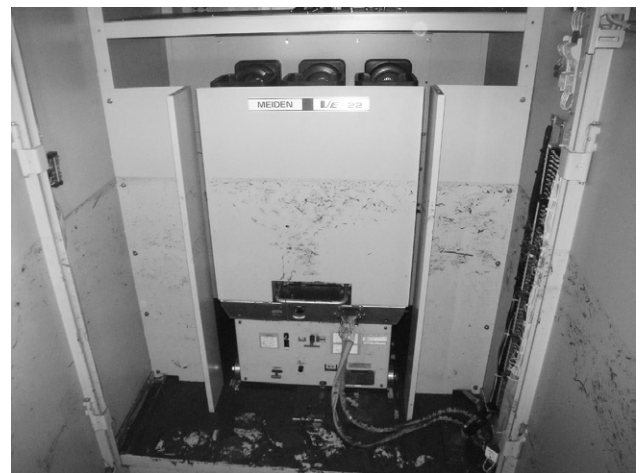
Fig. 5 22kV Switchgear Interior

The VCB installed inside the switchgear cannot be operated because there is an intrusion of seawater.

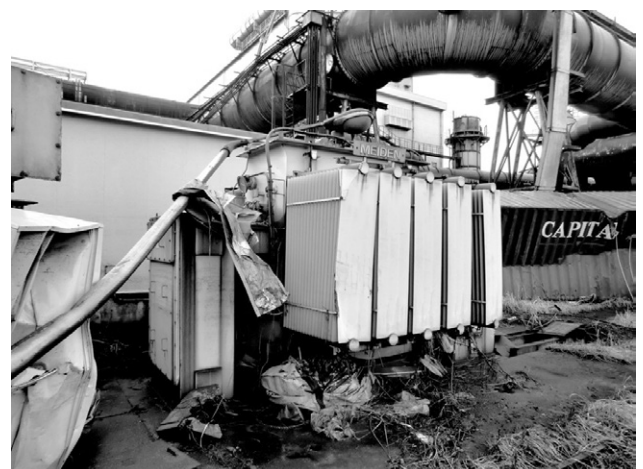
Fig. 6 Destroyed Transformer

Most of the extra high and high voltage oil-immersed transformers were submerged in seawater. We checked the conditions of damage in external appearance and analyzed insulation oil to determine the adequacy of reuse. **Fig. 6** shows the destroyed transformer.

The transformer is seriously damaged due to collision with driftage.

The target transformers were 24 units in all, from a 50MVA large-capacity transformer to small capacities of 200kVA. Except for three units damaged by rubble, flammable gases and water components contained in insulation oil were found kept within the standard control values and the exterior and bushings were washed with water as a remedial measure. We therefore concluded that reuse was possible.

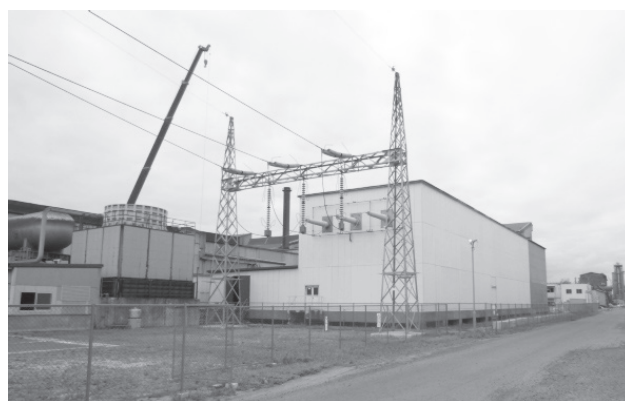
Fig. 7 Restored Power Receiving Substation

The picture shows the restoration from the damaged scene of **Fig. 1**.

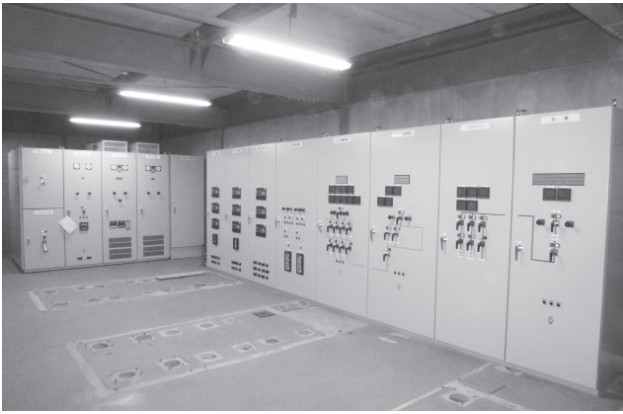
Fig. 8 Restored Field Monitoring Panel

The renovation of panels is completed and this marks total restoration.
