# Reconstruction Support in the Tohoku Region

**Keywords** Earthquake disaster, Recovery, Kennan Water Purification Center, Ohfunato Water Purification Center, Kesenuma Wastewater Treatment Plant, Yonai Water Purification Center, Mobile power generating system

## Abstract

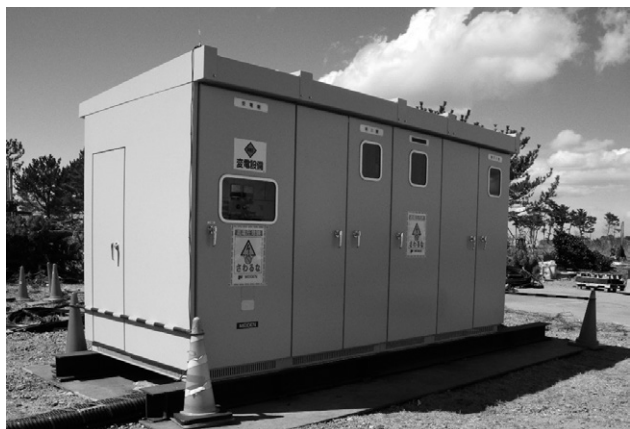
**Fig. 1** Temporary Outdoor Incoming Substation Facilities at the Kennan WPC

Temporary outdoor incoming substation facilities were installed to secure the power source for wastewater pumps, etc.

temporary power generating system. After the restoration of the utility system, the temporary incoming substation facility was installed. Fig. 1 shows the temporary outdoor incoming substation facility. In this manner, the function of wastewater pumping-up was assured. For the improvement of effluent water quality, a temporary sedimentation tank was installed inside the WPC so that we could secure the process from settling to sterilization.

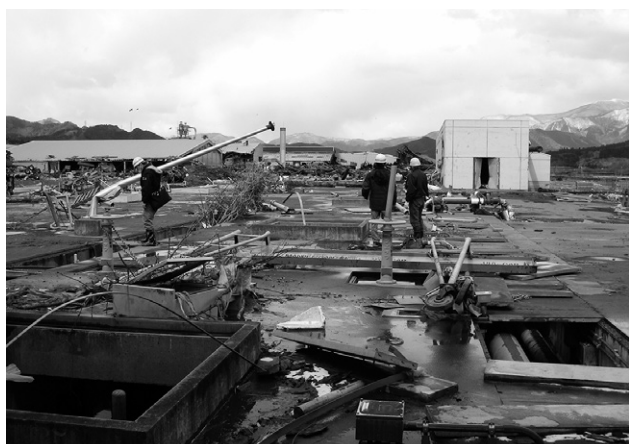
Fig. 3 Situation of Damage at the Upper Area of the Site in the Ofunato WPC

This WPC was hit by the tsunami and was submerged as high as the level just beneath the second floor of the Sludge Control Building. The first floor and the basement were completely submerged. Most facilities were severely damaged except for the electrical equipment installed in the operator room on the second floor of the control building. Fig. 3 shows situation of damage at the upper area.

The upper area of the WPC facilities was critically damaged by the direct hit of the tsunami.

ily installed piping system to a reactor tank used as a temporary sedimentation tank so that we could secure functions for the water processing sequence of pump-up – settling – sterilization – effluent.

Along with the recovery of the power supply from the power company, a temporary incoming power facility and wastewater pump control panel were installed to assure functions of automatic operation based on the water level of the wastewater pump. After that, a single system of a water purification facility was recovered using the temporary motor control panel.

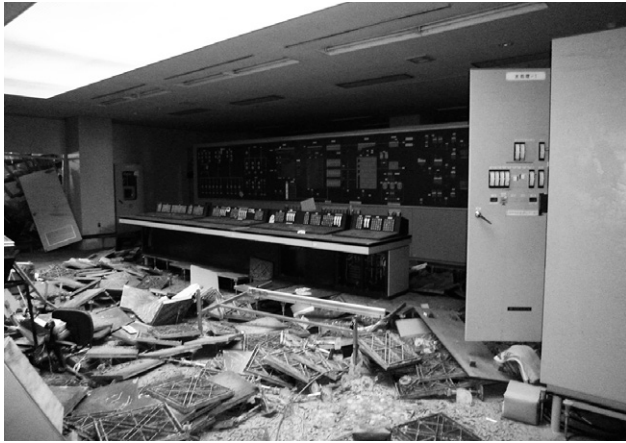
**Fig. 4** Situation of Damage in the Control and Monitor Room at the Kesenuma WWTP

treatment facilities were damaged. Machinery facilities were also devastatingly damaged. The damage then showed that treatment functions were completely lost and early recovery was impossible to achieve. Fig. 4 shows a view of damage in the control and monitor room of the main administration building.

The monitor room in the second floor of the administration building was directly hit by the tsunami and the WWTP site was destroyed.

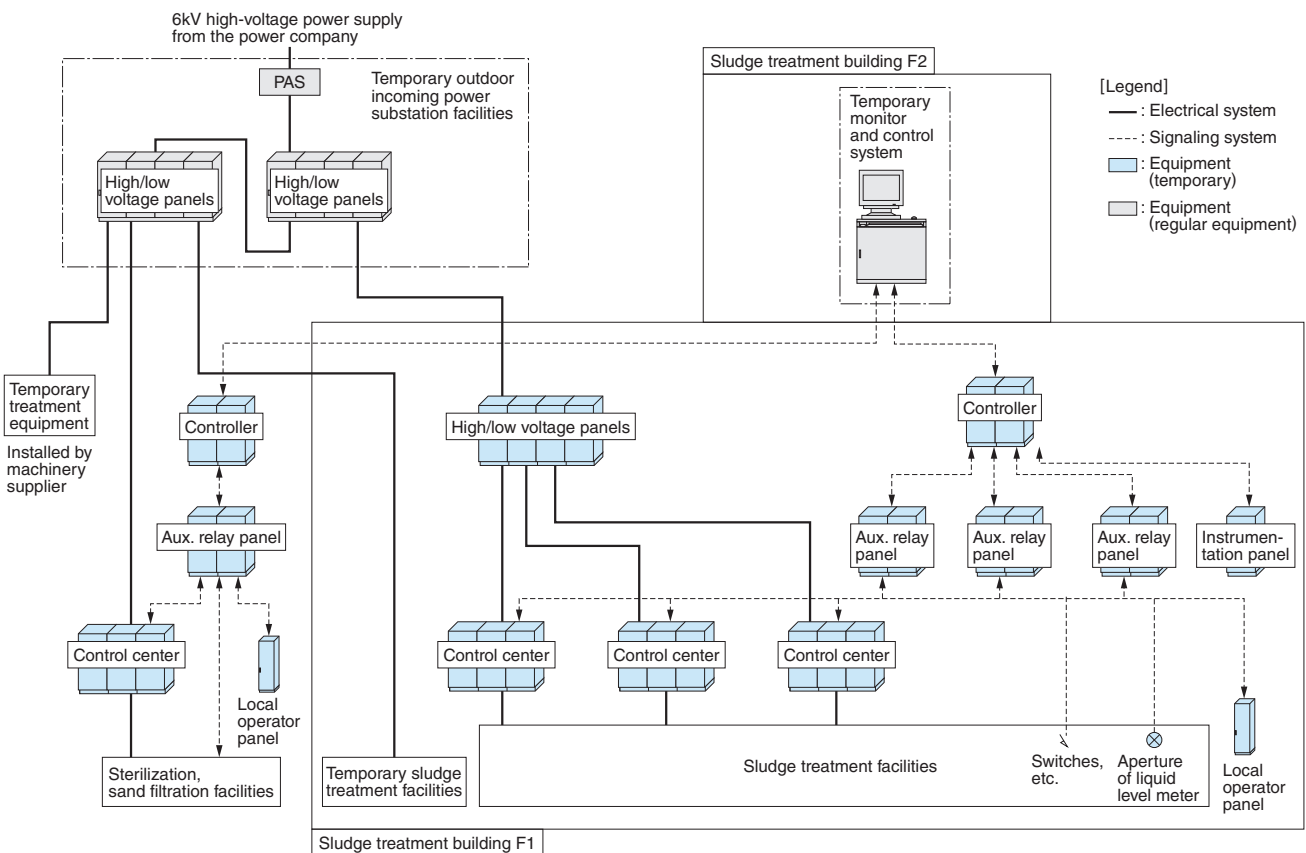
**Fig. 5** Schematic Diagram of the Kesenuma WWTP at the Stage of Recovery

In order to dispose of sludge generated in the temporary treatment facilities in the city, we took measures to attain complete recovery of the sludge treatment, sand filtration, and sterilization facilities. The incoming power substation and monitoring-control facilities were planned to be installed in the new administration building that was to be constructed. As remedial measures taken to support this WWTP, the power supply was tentatively taken from a temporary outdoor power incoming substation facility and monitoring and control were carried out from temporary monitoring and control system installed in the monitor room of the sludge treatment building. Fig. 5 shows a schematic diagram used at the stage of recovery.

Temporary incoming power substation and monitor and control system were installed in the administration building before regular construction.

Switchgear and panels were installed such that the windows and doors of each electricity room were destroyed. In order to avoid salt and other damage, we took special measures to produce and install temporary doors for electricity rooms. Due to construction work, it became impossible for any maintenance personnel to stay at night. As such, we temporarily installed a simplified remote monitoring system that uses a mobile phone network in order to perform remote monitoring and emergency communication.

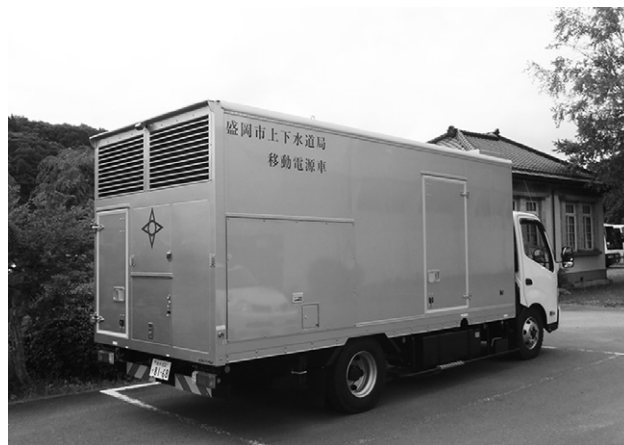
Fig. 6 Mobile Power Generating System at the Yonai WPC in Morioka City

- (1) Since the source voltage is high, existing high-voltage conveying pumps can be operated.
- (2) The connector panel was installed. The connection of high-voltage cables to the existing incoming power substation facilities could therefore, be easily made.
- (3) The total mass of the mobile power generating system vehicle is suppressed to not exceed 8t. A truck driver can therefore move this system to any place.

It can make cable connections to the rear of the vehicle. Electric power can be supplied when cables are connected to the distribution substation facilities of the Purification Center.
