**MEIDEN**

# Recommendation of Insulation Diagnosis of High-Voltage Electrical Equipment

*Periodic maintenance  
is also important for  
high-voltage electrical  
equipment*

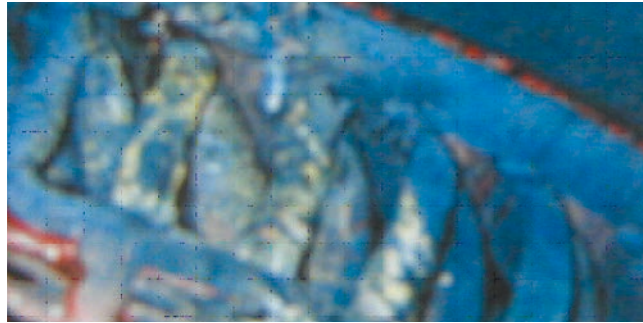
**Insulation breakdown of generator stator coils**

**Years in operation** 20 years  
**Accident condition** Insulation breakdown at the coil end  
**Estimated cause** The fixing force of the coil deteriorated, and so the electromagnetic forces at the time of motor startup caused vibrations, resulting in wear and leading to insulation breakdown.

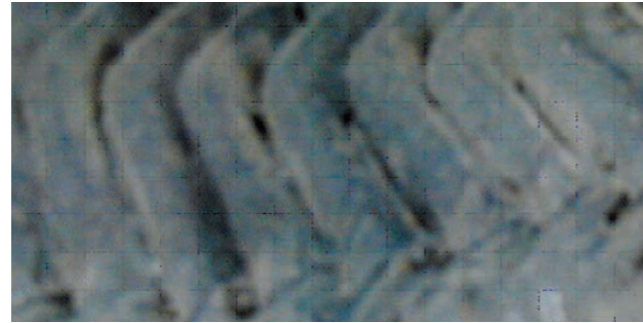
**Insulation breakdown of electric motor stator coils**

**Years in operation** 20 years  
**Accident condition** Insulation breakdown in the slot part  
**Estimated cause** The coil overheated due to the accumulation of dust, causing thermal deterioration and leading to insulation breakdown.

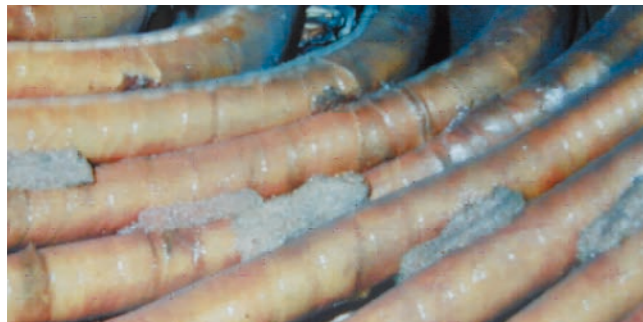
**Insulation breakdown of electric motor stator coils**

**Years in operation** 18 years  
**Accident condition** Insulation breakdown at the coil end  
**Estimated cause** Switching surges, etc., overlapped at locations where insulation deterioration from thermal and mechanical stress had progressed, leading to insulation breakdown.

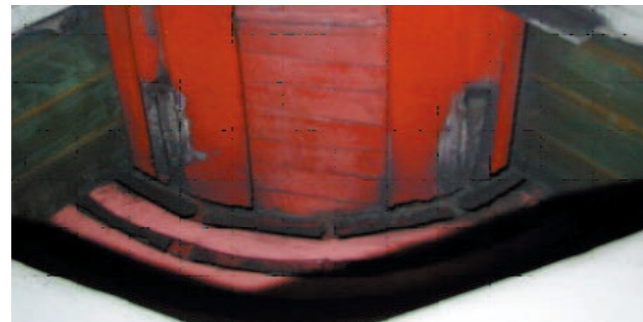
**Transformer with insulation breakdown**

**Years in operation** 19 years  
**Accident condition** Insulation breakdown on the side of the secondary winding  
**Estimated cause** Accumulation of dust on the winding surface, moisture absorption after stopping, and incursion of switching surges simultaneously occurred, leading to insulation breakdown.

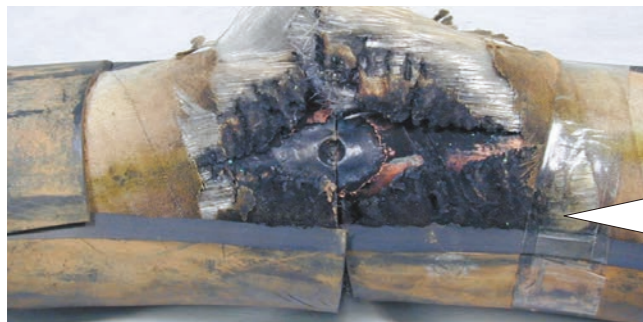
**High-voltage cable with insulation breakdown**

**Years of use** 27 years  
**Estimated cause** Water tree deterioration progressed, leading to insulation breakdown.

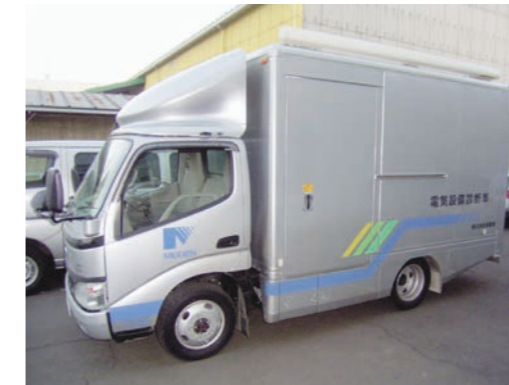
Electric equipment diagnosis vehicle

- (1) Diagnosis of the object equipment is possible if it is within 50 m of the diagnosis vehicle. Measurement is possible even at locations that cannot be reached by the diagnosis vehicle because the diagnosis equipment is portable and can be unloaded from the diagnosis vehicle.
