Comprehensive Diagnostic Evaluation Method for Power Receiving Substation Facilities and Various Live-Line State Diagnostic Technologies

Abstract

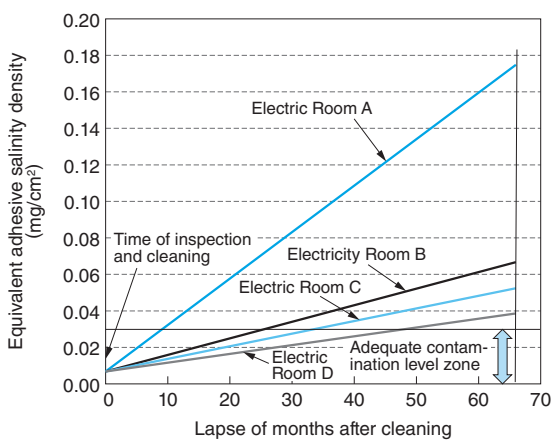
Fig. 2 Prediction Graph of Transitions in Contamination Levels as the Value of Equivalent Adhesive Salinity Density

Intervals of inspection and cleaning can be optimized by prediction of transitions in contamination level.

Fig. 2 shows the prediction graph of transitions in contamination levels as the value of the equivalent adhesive salinity density. According to the result of this diagnosis, it is obvious that the level of pollution in the Electric Room A is higher than the other electric rooms in three places. In this manner, it is possible to propose adequate cleaning frequency and environmental improvements. By combining the data of temperatures and humidity with those of level of pollution together, we will be able to expect application of this method to the environmental diagnostic system mainly for the risk assessment of occurrence of tracking phenomena on the insulation surface.

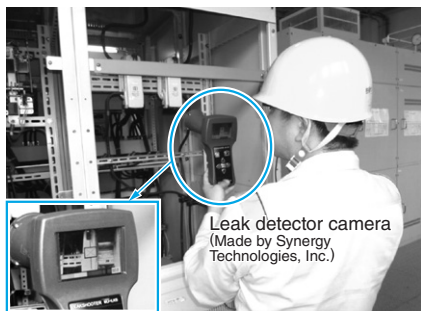
(a) Various high-frequency measuring instruments (commercial products)

(b) A view of diagnosis by a corona detector with a camera

Fig. 3 Example of Partial Discharge Diagnosis Detected by Ultrasonic Microphone

Various high-frequency measuring instruments and a view of partial discharge diagnosis are shown.

Since frequencies of partial discharge sound cannot be heard by human ears, we usually employ high-frequency measuring instruments such as high-frequency microphones and Acoustic Emission (AE) sensors for diagnosis. Fig. 3 shows an example of partial discharge diagnosis detected by an ultrasonic microphone. Fig. 4 shows an example of waveforms obtained from partial discharge diagnosis by using an AE sensor. Fig. 5 shows a view of partial discharge diagnosis by an AE sensor.

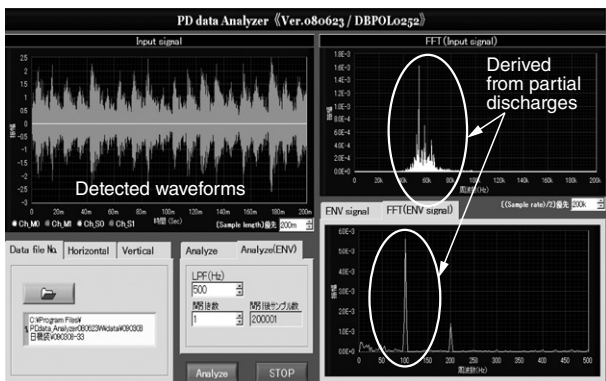
(a) System configuration for partial discharge measurement by an AE Sensor

(b) Example of partial discharge signal analysis

Fig. 4 Example of Waveforms Obtained from Partial Discharge Diagnosis by Using an AE Sensor

System configuration for partial discharge measurement and an example of partial discharge signal analysis are shown.

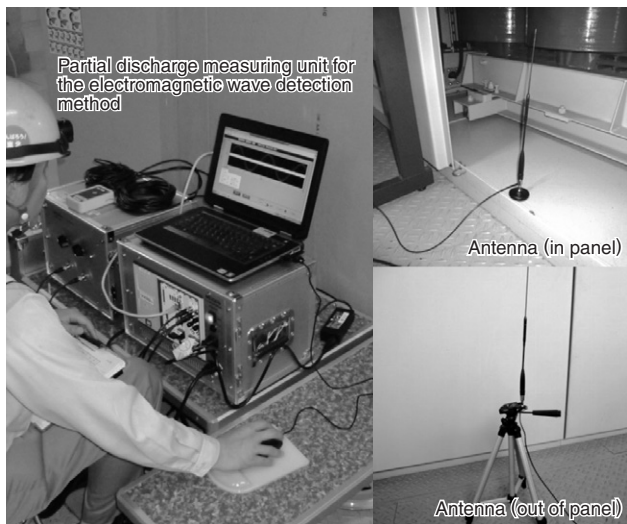
Fig. 7 View of Partial Discharge Measurement by Electromagnetic Wave Detection

A view of partial discharge diagnosis by electromagnetic wave detection is shown.

an example of waveforms obtained from partial discharge diagnosis by electromagnetic wave detection and **Fig. 7** shows a view of partial discharge measurement by electromagnetic wave detection.

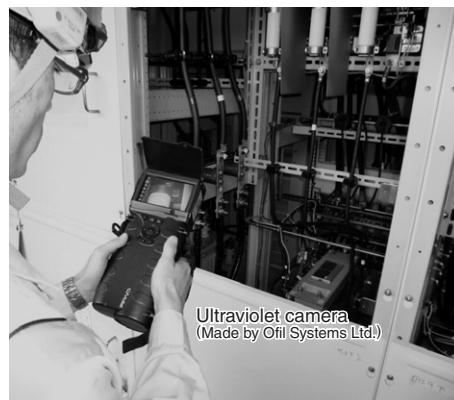
(a) A view of diagnosis

tial discharges. When such ultraviolet rays are detected, it is possible to identify the location of partial discharge generation (insulation deterioration part). Fig. 8 shows an example of partial discharge diagnosis by using an ultraviolet camera.
